Inspection Report

Minerals Regulatory Program

Mine Name: Expectation
Operator Name: Mark Miller

Permit number: M0350024
Inspection Date: October 26, 2006
Time: About 1:30-2:30 PM

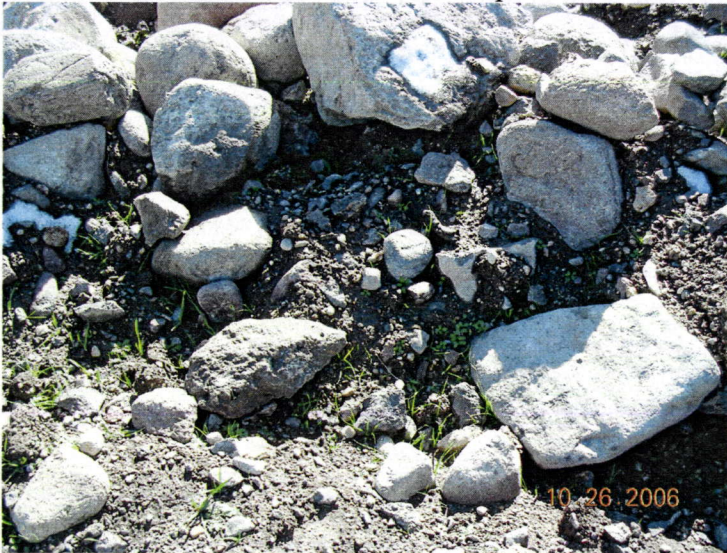
There are two areas I thought had been seeded. One is on the west side of the permitted area and the other is a hillside below the power lines (Photo 4). It appears only the area on the west was seeded. We saw numerous grass seedlings in this area (Photo 1), and while there is some cheatgrass, most of the grass appears to be other species, probably those that were seeded.

Photo 1. Grass seedlings in one of the regraded areas.

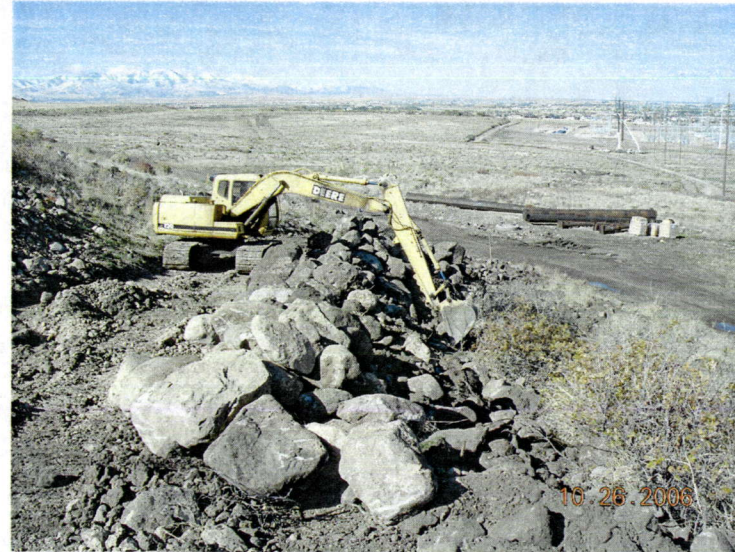
While we were at the site, a trackhoe was digging next to one of the roads accessing the mine site from the north (Photos 2 and 3). We did not see any of the rock being hauled away, but it appeared to

us that the operator was digging rock. This activity was being done outside the permitted disturbed area.

Photo 3. Another view of the area in Photo 2. It appeared the operator was digging rocks.

Because the operator was mining outside the permitted area, I issued cessation order MC2006-03-13-01 for failing to conduct operations as shown in the Notice of Intention to Commence Small Mining Operations (NOI) and for failing to maintain adequate surety. This cessation order was issued October 30, 2006.

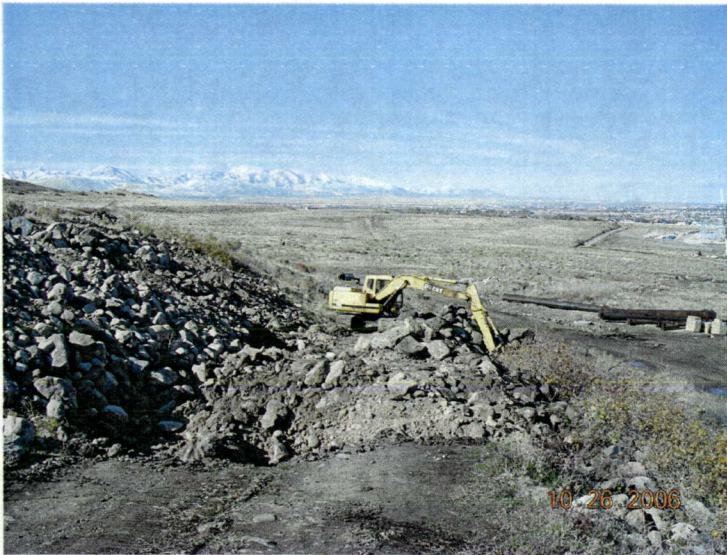
Photo 2. Trackhoe operating along a road north of the mine.

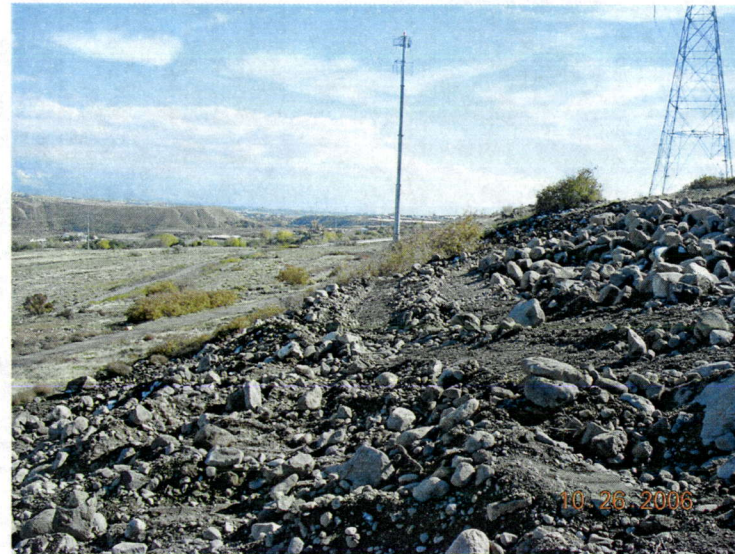
Photo 4. An area below and east of the power lines. It does not appear this area was seeded.

On November 14, 2006, I discussed the bonding requirement with the operator and agreed that if all unpermitted disturbed areas could be seeded, cessation order MC2006-03-04-01 could be modified to simply require the seeding and it could then be terminated.
